# Final Report

Implementation and Assessment of the Effectiveness of the Green Infrastructure Technology in  
Newark, NJ

Prepared by  
INTERSTATE ENVIRONMENTAL COMMISSION and EDESIGN DYNAMICS, LLC

December, 2010  
**REVISED January 2011**

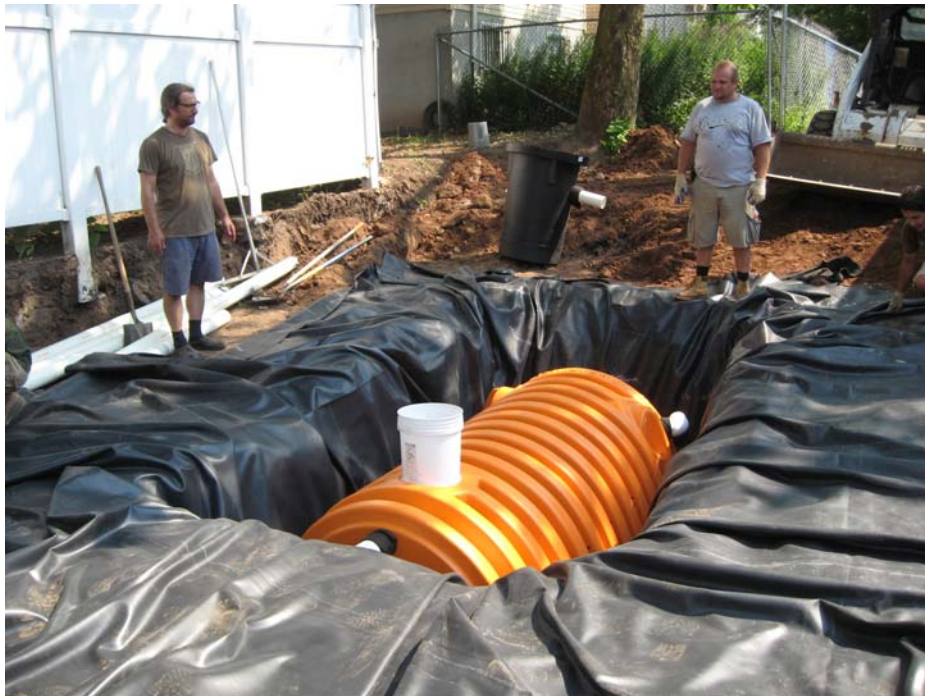
### 2. July, 2009 | Installation of Subsurface Cistern

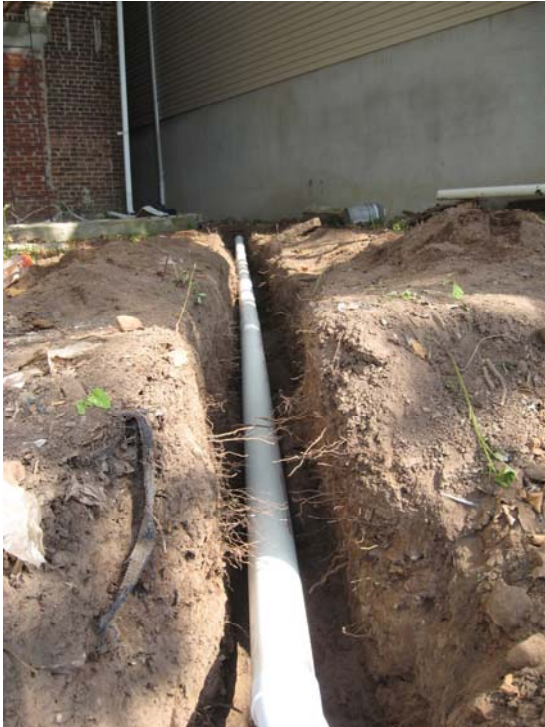
3. July, 2009 | Installation of adjacent residential downspout

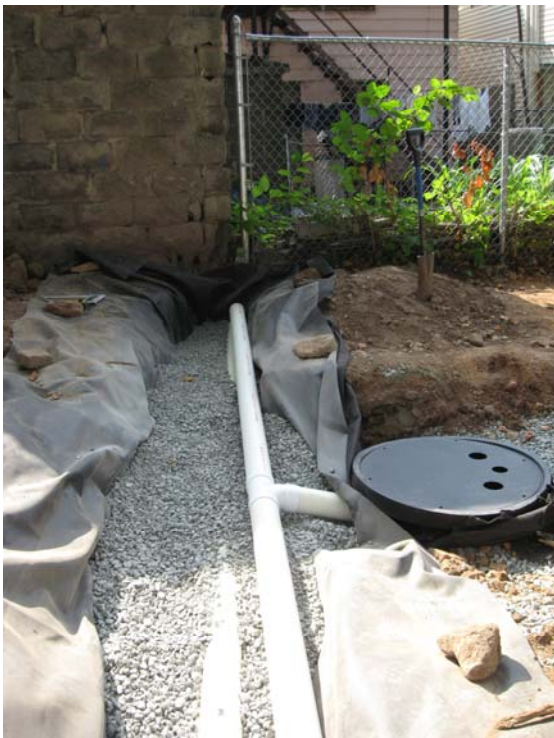
4. July, 2009 | Installation of French drain

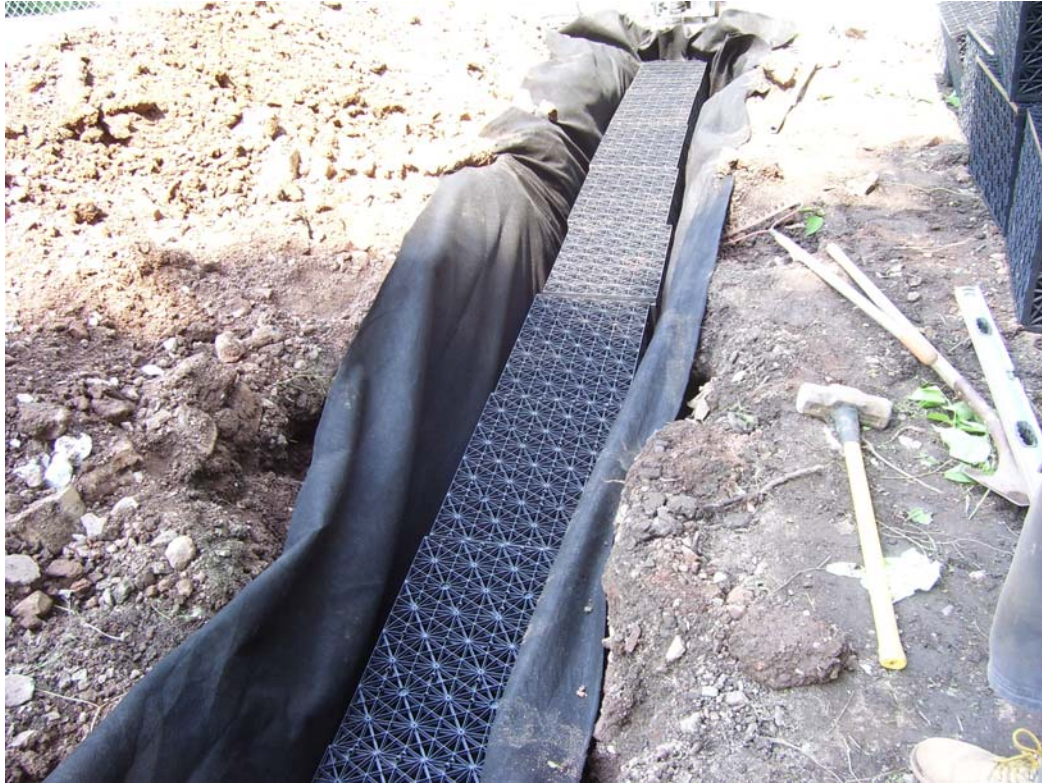
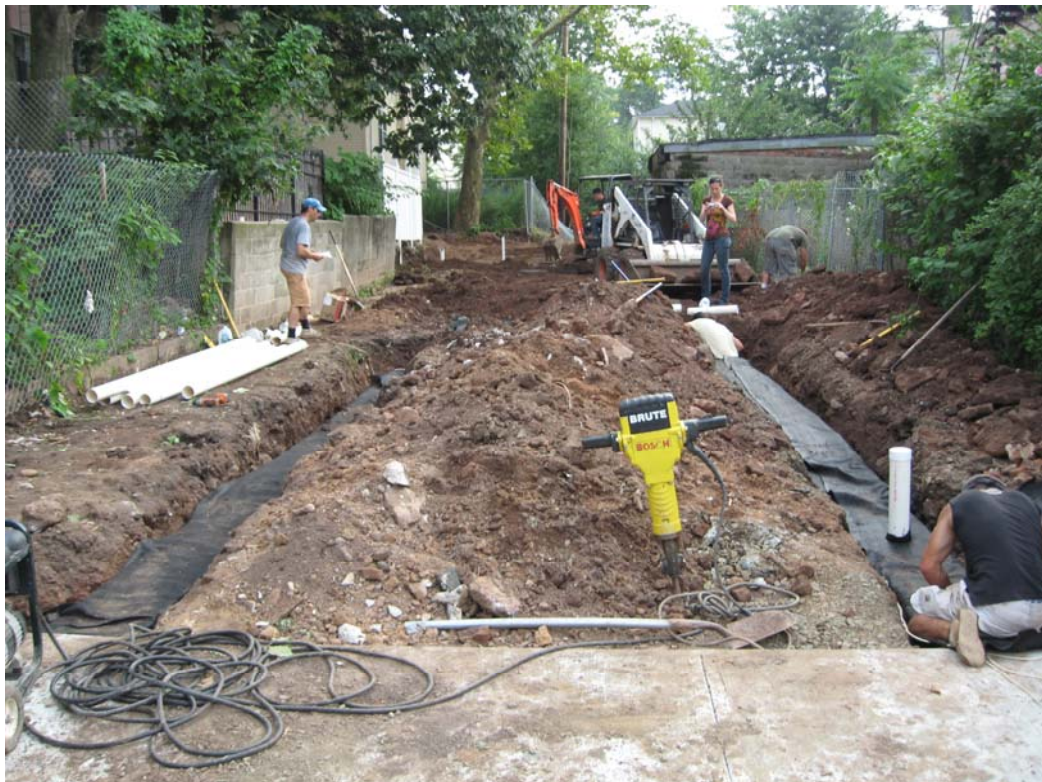
5. August, 2009 | Installation of infiltration galleries

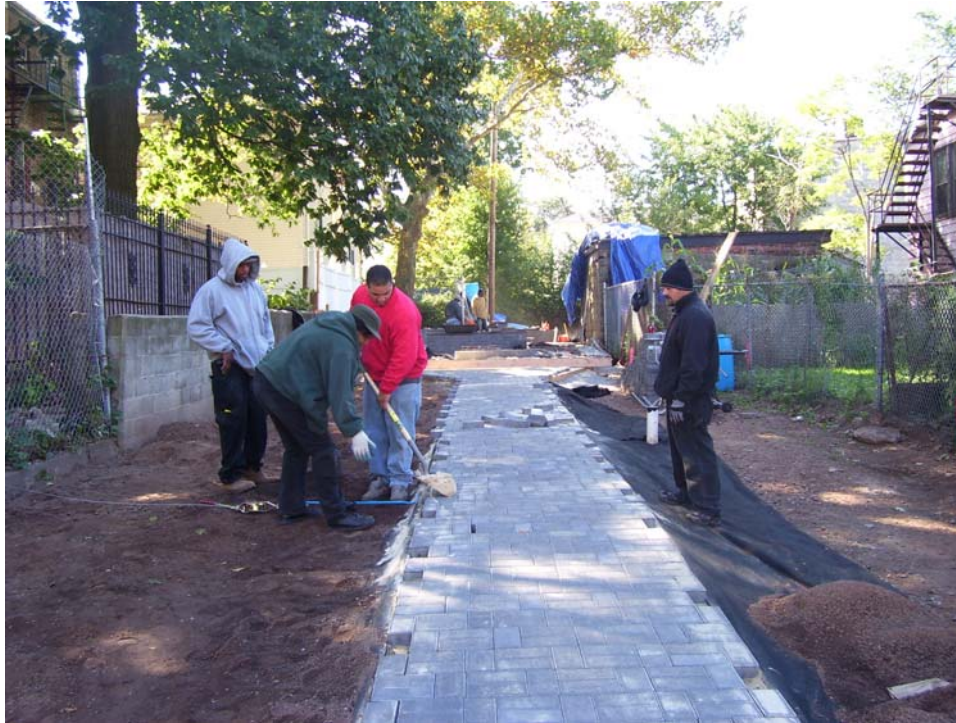
6. October, 2009 | Installation of permeable paver walkway

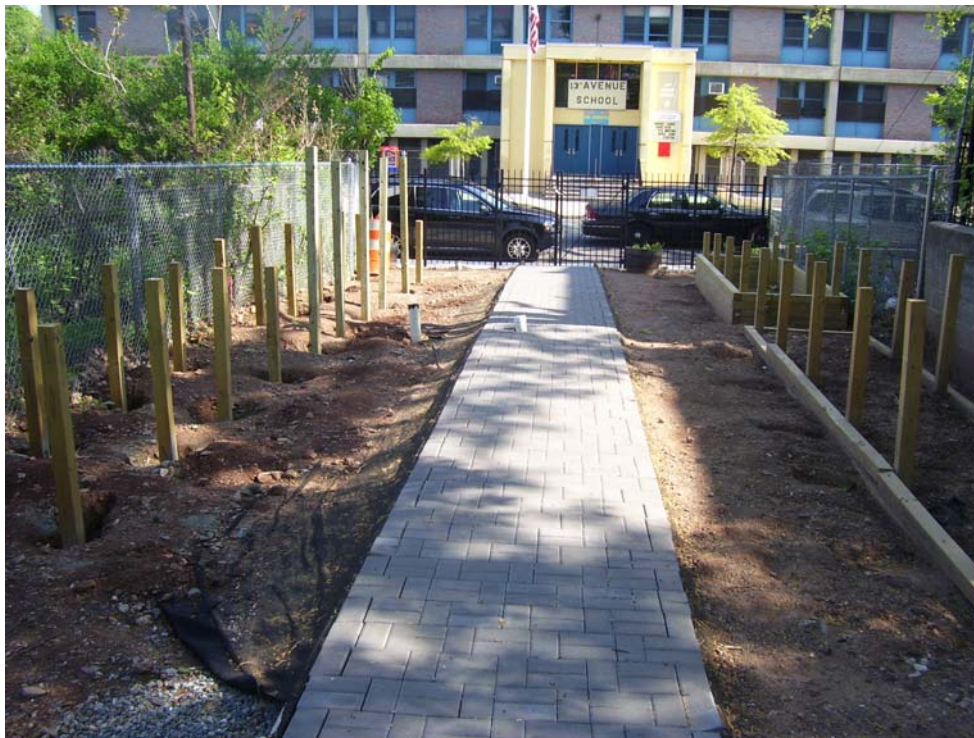
7. April, 2010 | Installation of raised planting beds and barrel platform

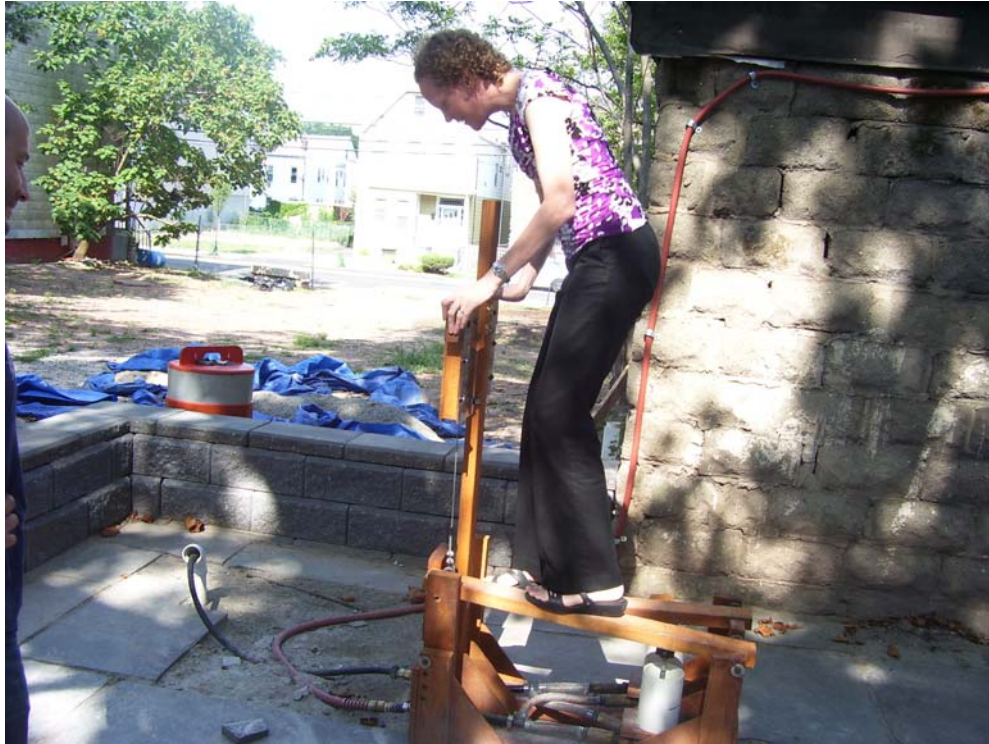
8. August, 2010 | Operation of treadle play pump

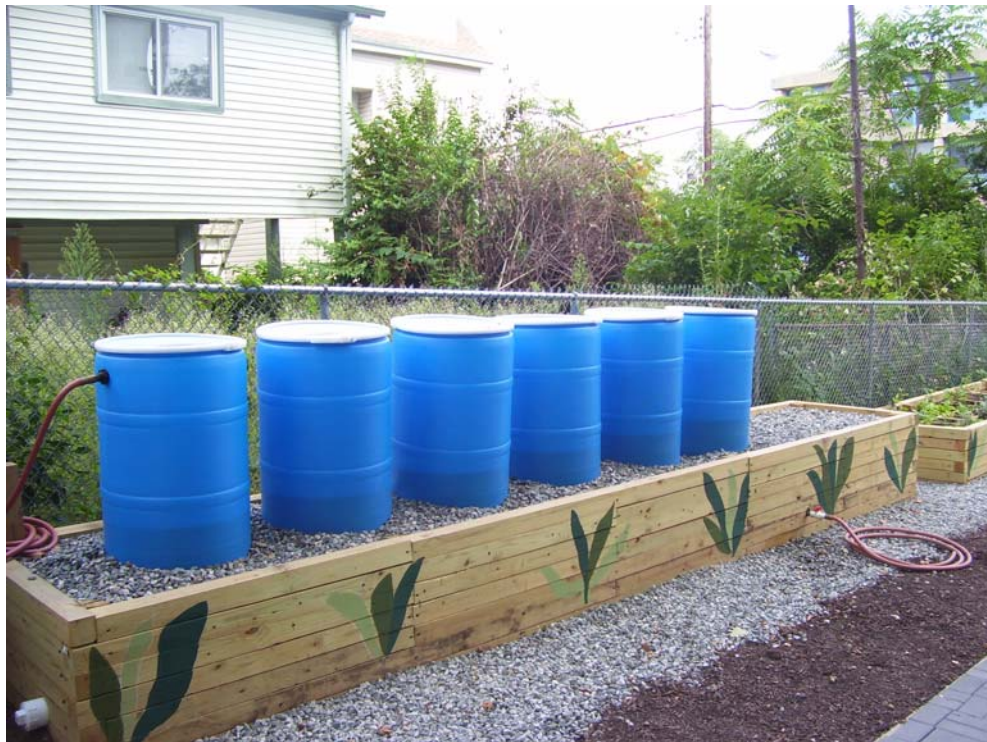
9. August, 2010 | Raised barrel platform
