Combined
Sewer Overflow Study
for the
Hudson River Conference
August 1972
Interstate Sanitation Commission

COMBINED SEWER OVERFLOW STUDY

HUDSON RIVER CONFERENCE

INTERSTATE SANITATION COMMISSION

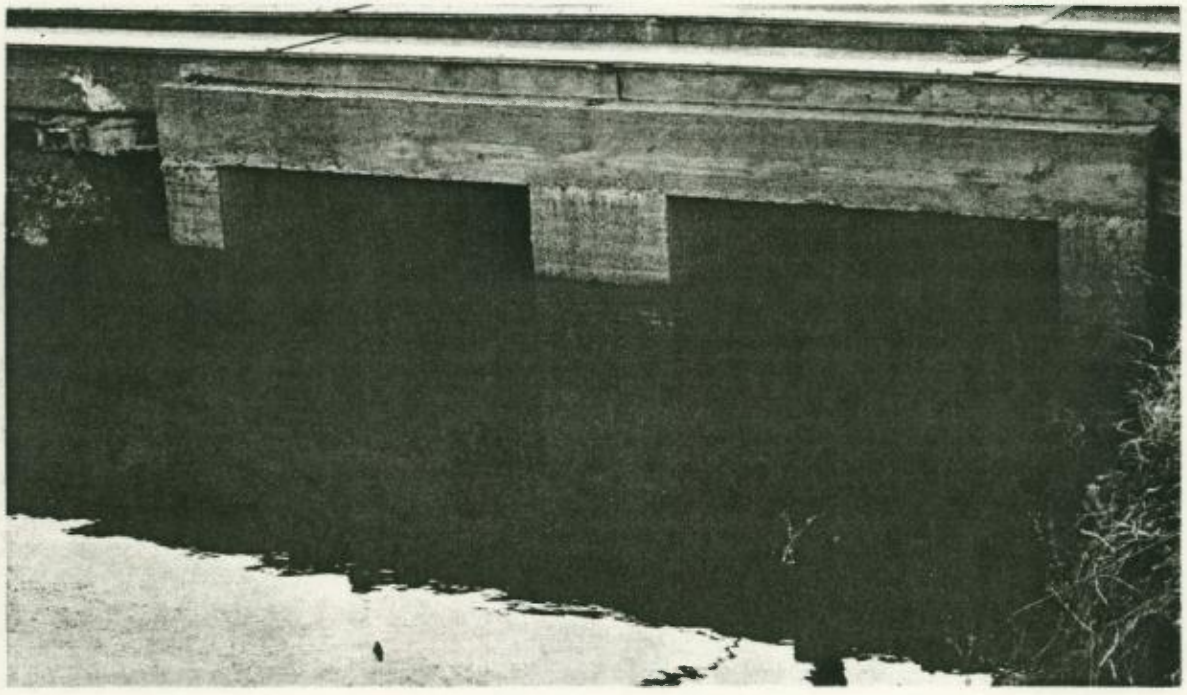
A regulator typical of those found in this survey is shown in Figure 10-A. Figure 10-B is somewhat typical of the outfalls observed in this study.

FIG. 10-A, HYDRAULICALLY OPERATED SLUICE GATE AT REGULATOR 6 (CONTRACT 2), NICHOLAS AVENUE AND RICHMOND TERRACE, PORT RICHMOND, NEW YORK

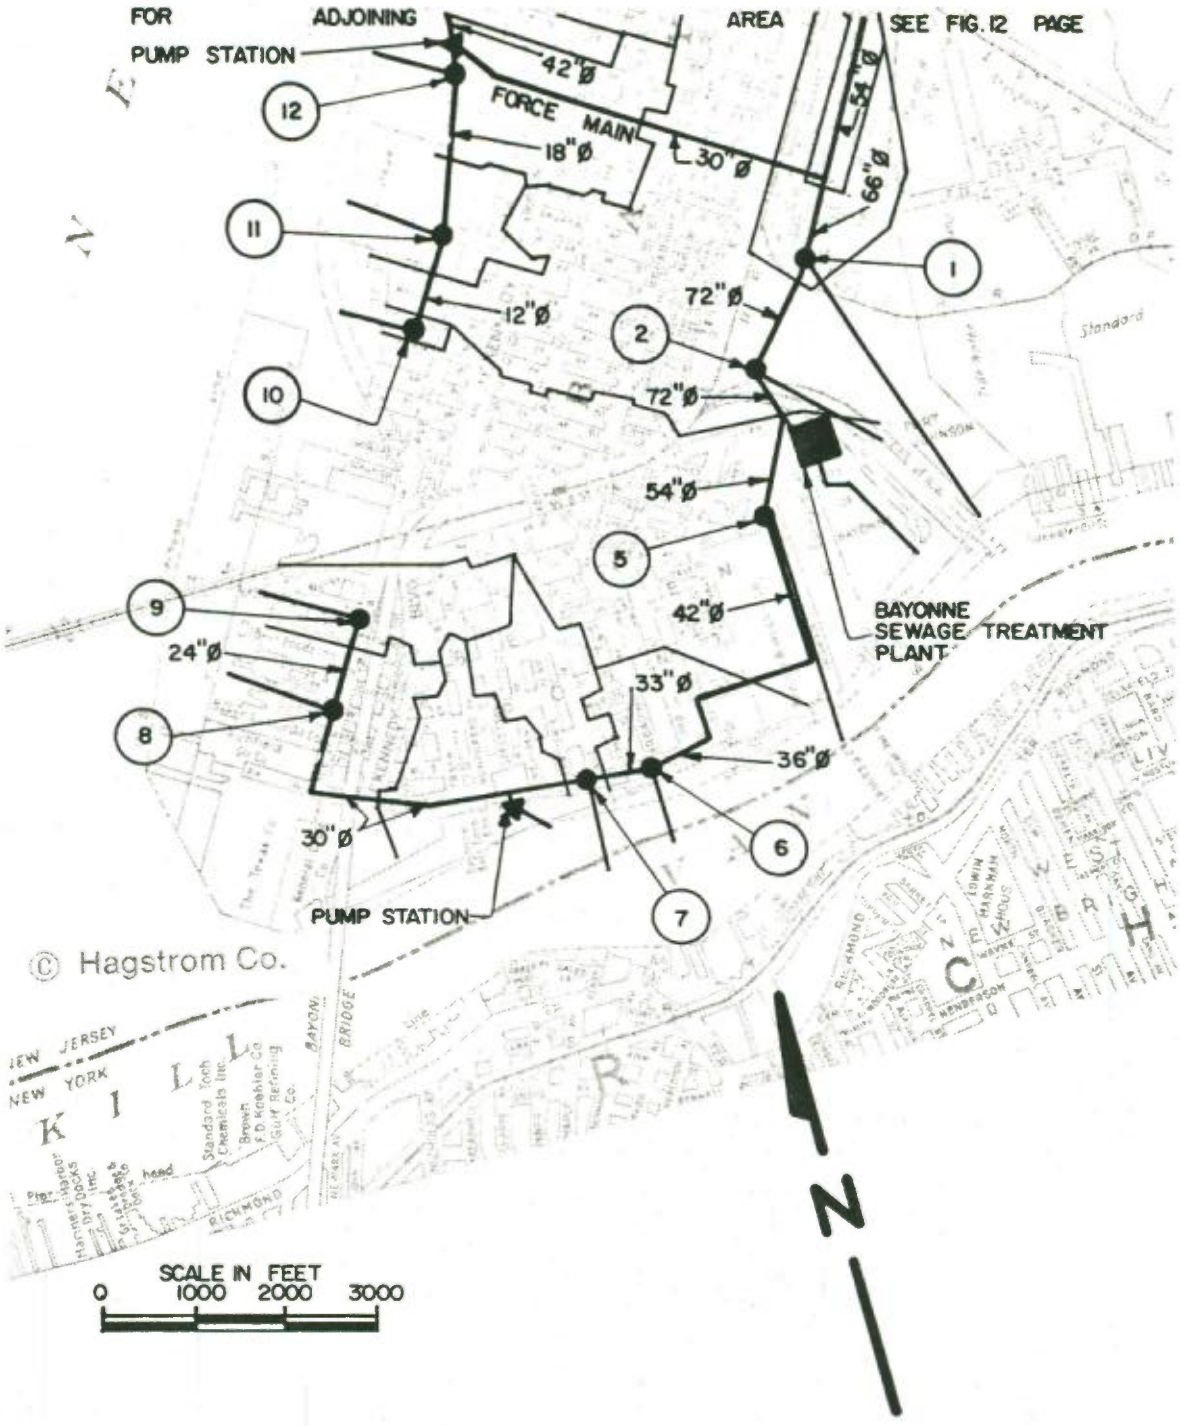
FIG. 11 BAYONNE
HUDSON CO. N.J.
DRAINAGE BASIN
AND
REGULATOR LOCATIONS

During the Commission's inspections, nine of the system's eighteen regulators were found to be inoperable. A follow-up telephone conversation with the plant superintendent indicated that all regulators had been placed back into operable condition since our field investigation.

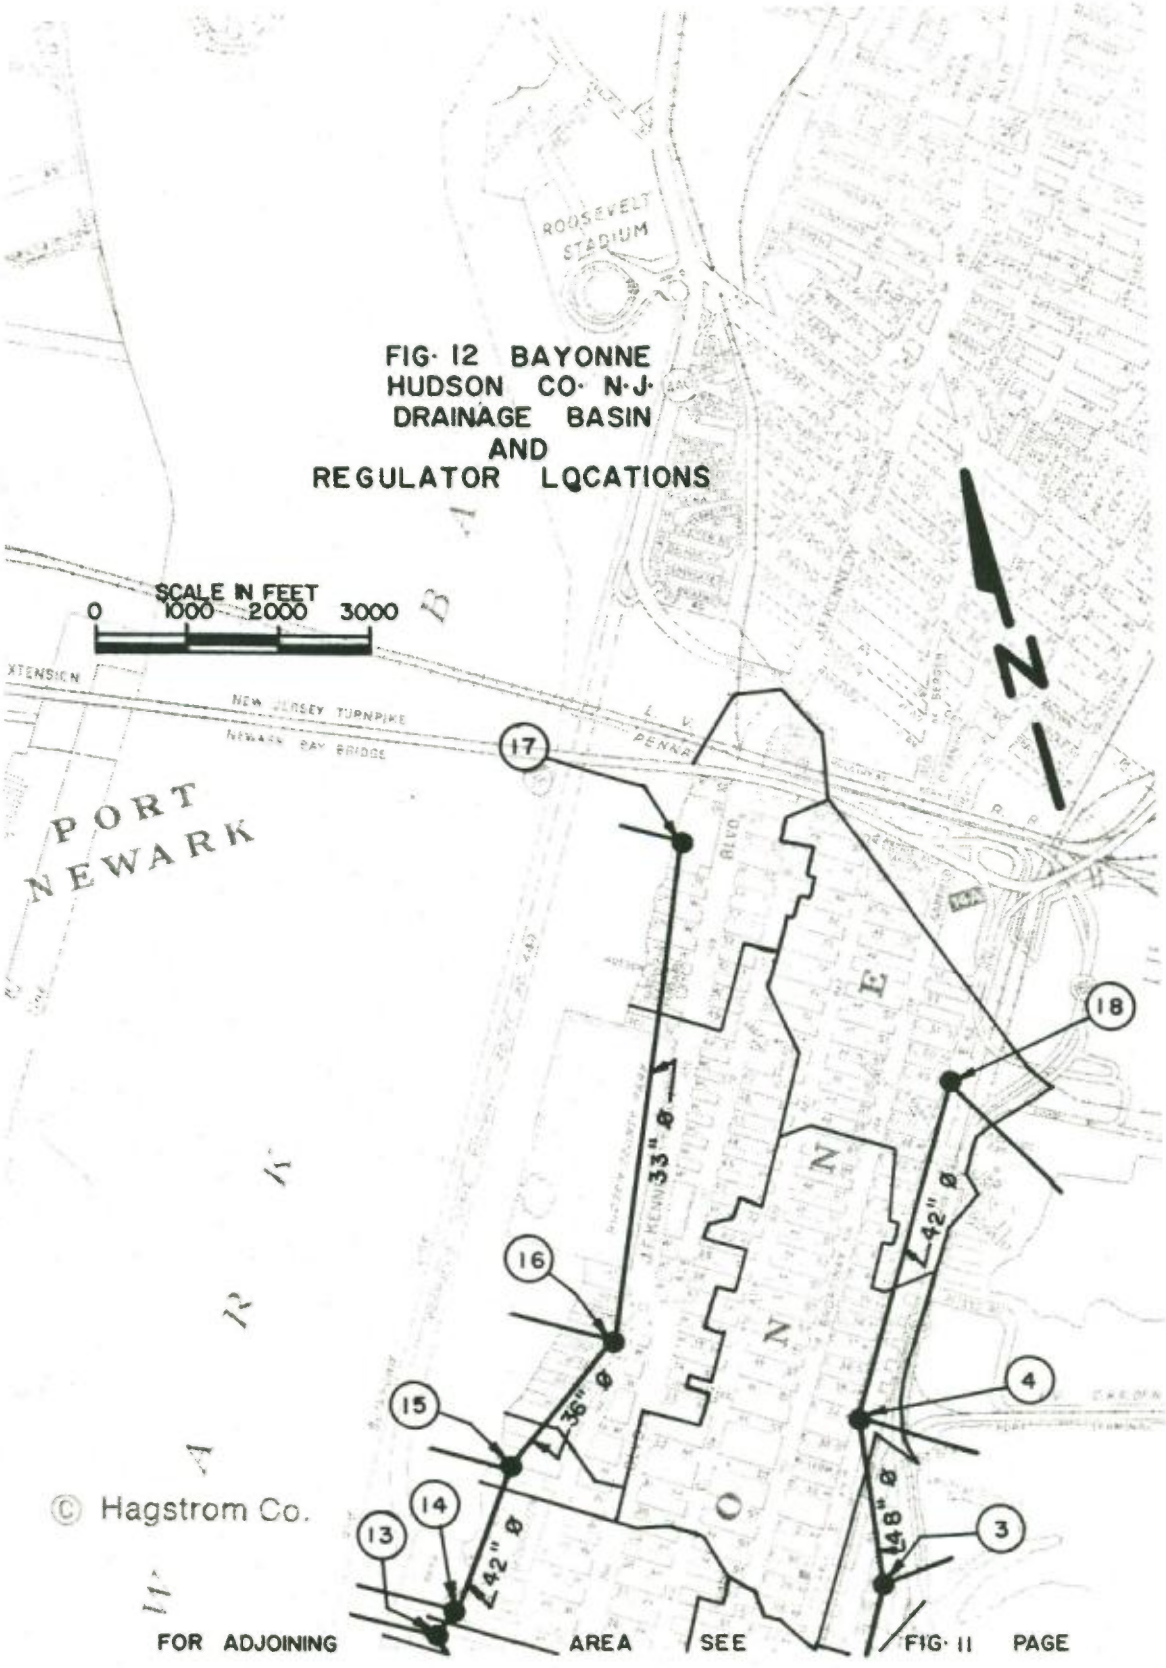
FIG· 12 BAYONNE
HUDSON CO· N·J·
DRAINAGE BASIN
AND
REGULATOR LOCATIONS
SCALE IN FEET
0 1000 2000 3000
N
ROOSEVELT STADIUM
NEW JERSEY TURNPIKE
NEWARK BAY BRIDGE
PORT NEWARK
BAYONNE
17
18
16
15
14
13
4
3
33" ø
42" ø
36" ø
42" ø
48" ø
© Hagstrom Co.
FOR ADJOINING AREA SEE FIG· 11 PAGE

Regulator Number	LINE SIZE CHARACTERISTICS					Receiving Waterway	INSPECTION DATA			Figure No. for Location of Regulator
	Interceptor Line		Trunk Line	By-Pass Line	Outfall		Date	Operable (Yes or No)	Comments	
	Upstream	Downstream								
16	36" ø RC	36" ø RC	36" ø CI	36" ø CI	36" ø CI	Newark Bay	3-27-72	Yes	--	12
17	--	33" ø	36" ø CB	36" ø CB	36" ø CB	Newark Bay	3-27-72	No.	This is a new regulator, recently built. It replaces Brown & Brown regulator No. 4-A which was at site and was removed because of new construction. Regulator gate was closed. Dry weatner flow by-passing.	12
18	--	42" ø	48" ø	48" ø	48" ø	Upper New York Bay	9-29-71	No	Float weighted down to keep regulator gate in open position. Needs greasing and general maintenance. Tide gate jammed open -- fixed by crew while at chamber.	12

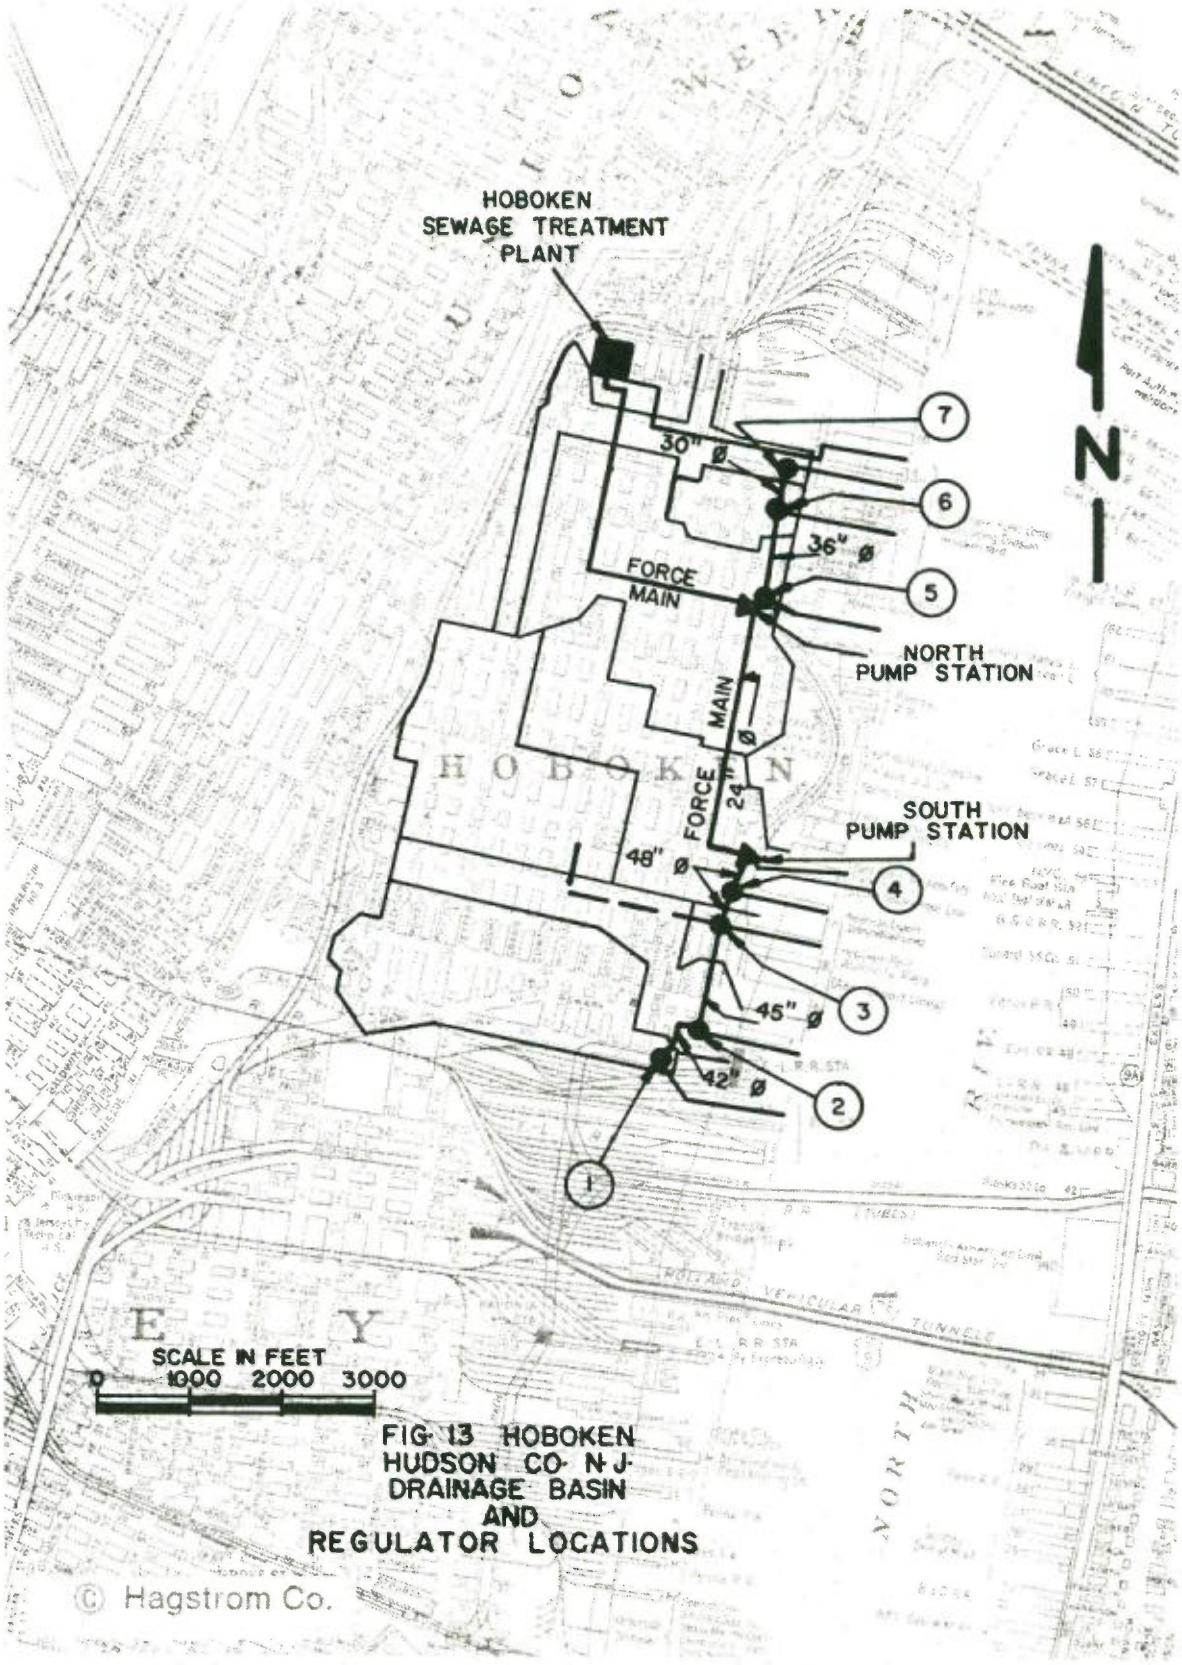
FIG. 13 HOBOKEN
HUDSON CO. N.J.
DRAINAGE BASIN
AND
REGULATOR LOCATIONS

Inspection of the Hoboken sewage system indicated all regulators to be non-operable. A follow-up telephone conversation with the plant superintendent indicated that repair work is currently in operation on the north-end regulators.

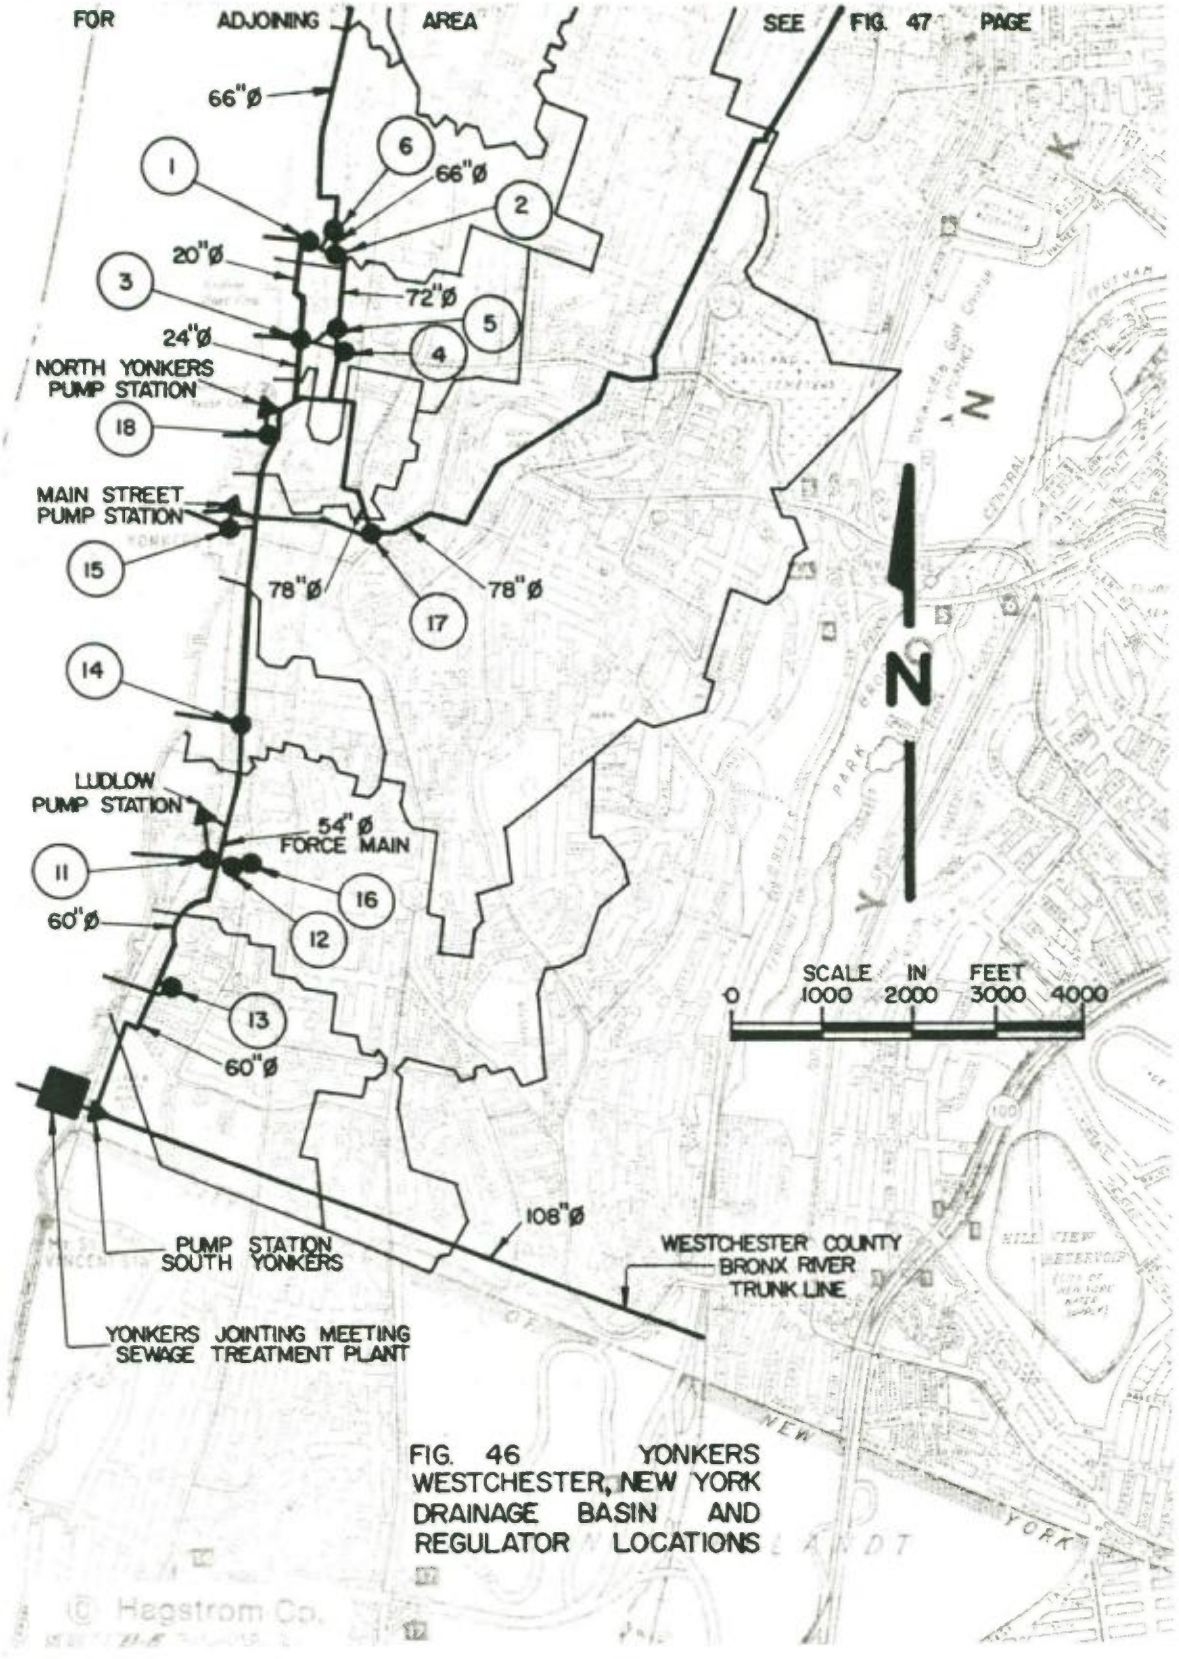
FIG. 46 YONKERS WESTCHESTER, NEW YORK DRAINAGE BASIN AND REGULATOR LOCATIONS

During the field inspection by the Commission, five of the regulators were found to be non-operable. According to a follow-up telephone conversation with the Chief of Regulator Maintenance, Westchester County Department of Environmental Facilities, repair work is continuing on those regulators which are inoperable.

Regulator Number	LINE SIZE CHARACTERISTICS					Receiving Waterway	INSPECTION DATA			Figure No. for Location of Regulator
	Interceptor Line		Trunk Line	By-Pass Line	Outfall		Date	Operable (Yes or No)	Comments	
	Upstream	Downstream								
8	66" ø RC	18" ø CI BR INT To 66" ø RC	30" ø CI	30" ø CI	30" ø CI	Hudson River	6/8/72	- -	Not Able to Locate.	47
9	66" ø RC	24" ø CI BR INT To 66" ø RC	30" ø CI	30" ø CI	30" ø CI	Hudson River	6/7/72	No	Equipment Corroded. Gate Frozen in Open Position. Difficult Access.	47
10	60" ø RC	12" ø CI BR INT To 60" ø RC	4'-0" x 4'-0" RC	4'-0"x 4'-0" RC	4'-0" x 4'-0" RC	Hudson River	6/7/72	Yes	- - -	47
11	---	14" ø CI BR INT To LUDLOW PUMP HOUSE	3'-1" x 3'-6" EGG SHAPED BRICK & 54" ø BRICK	7'-0" x 4'-6" SEMI-CIRCULAR BRICK	7'-0" x 4'-6" SEMI-CIRCULAR BRICK	Hudson River	6/8/72	Yes	- - -	46
12	---	42" ø CI BR INT	54" ø BRICK	54" ø BRICK	54" ø BRICK	Hudson River	6/8/72	No	Hinged Gate Frozen in Open Position. No Connection Between Gate and Float.	46

13	---	30" ø CI BR INT To 60" ø RC	48" ø BRICK	48" ø BRICK	48" ø BRICK	Hudson River	6/8/72	Yes	Difficult to Maintain Equipment Properly Because of Restricted Working Space.	46
14	---	20" ø CI BR INT	3'-6" x 2'-7" EGG SHAPED BRICK	3'-6" x 2'-7" EGG SHAPED BRICK	3'-6" x 2'-7" EGG SHAPED BRICK	Hudson River	6/7/72	No	Equipment Corroded.	46

Inspection Data - According to phone conversation of June 30, 1972 with Chief of Regulator Maintenance, Weschester County Department of Environmental Facilities, repair work is continuing on those regulators which are inoperable. Also, the two regulators which were not located during the field inspection, were said to be in similar condition as regulator 9.

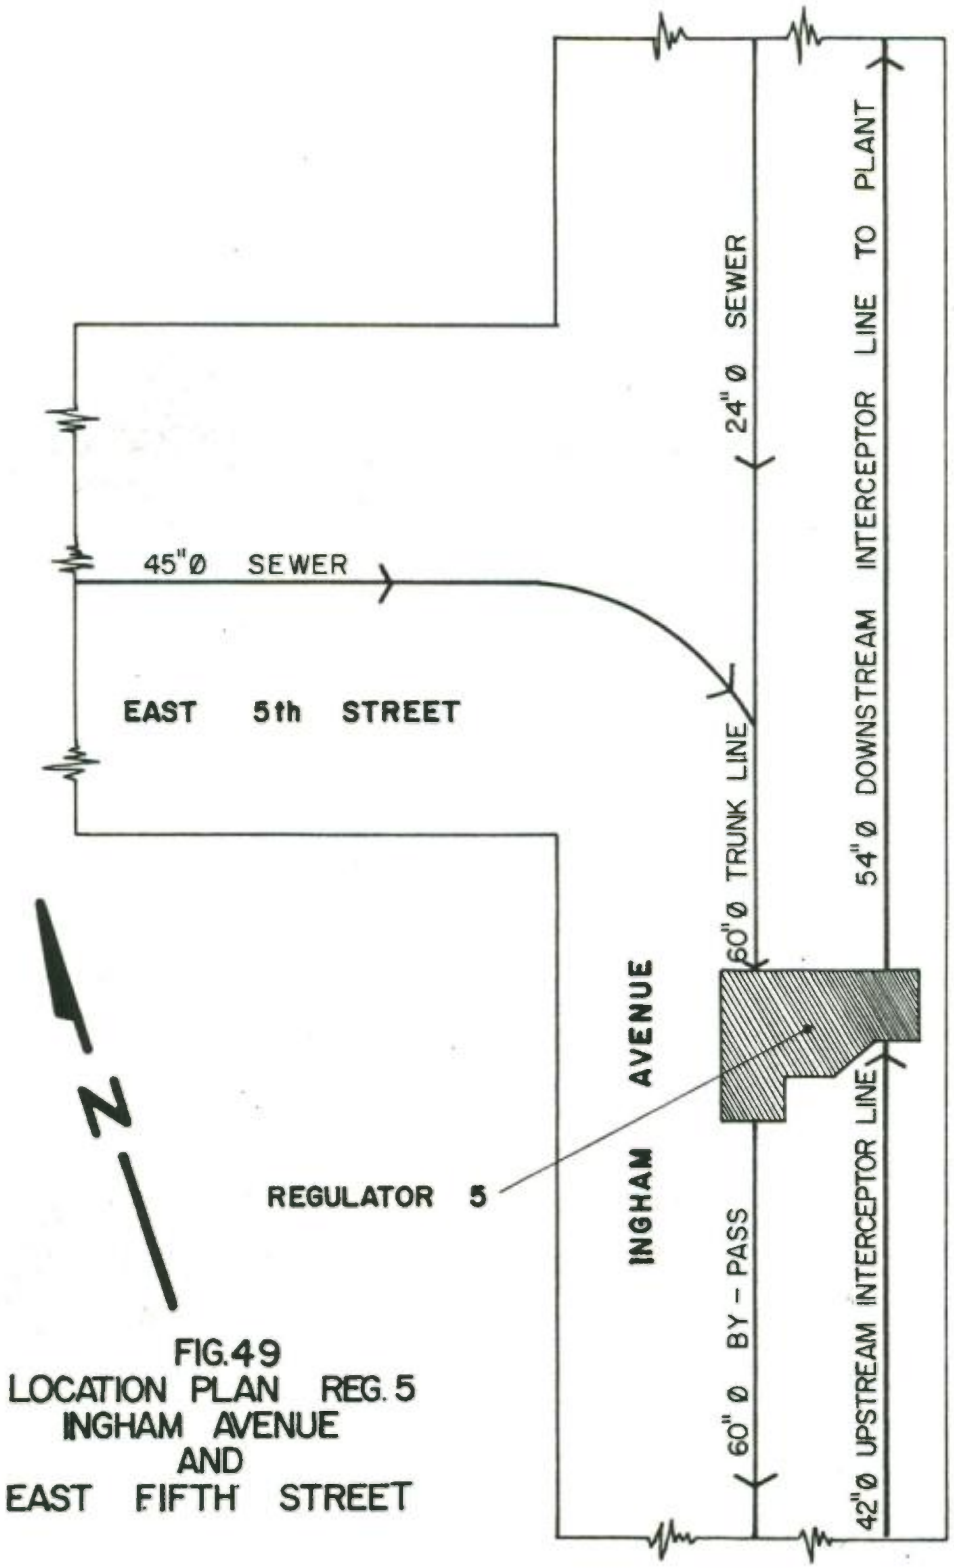
FIG. 49
LOCATION PLAN REG. 5
INGHAM AVENUE
AND
EAST FIFTH STREET

A land use map for Regulator No. 5 located at Ingham Avenue south of East 5th Street in Bayonne is shown on Figure 48, and the land use and demographic characteristics of the drainage basin for this regulator are shown in Table 11. The table shows that this drainage basin is approximately 50% residential and 30% industrial. A location plan of the regulator is shown in Figure 49. Figures 50-A and 50-B are photographs showing flows associated with the regulator.

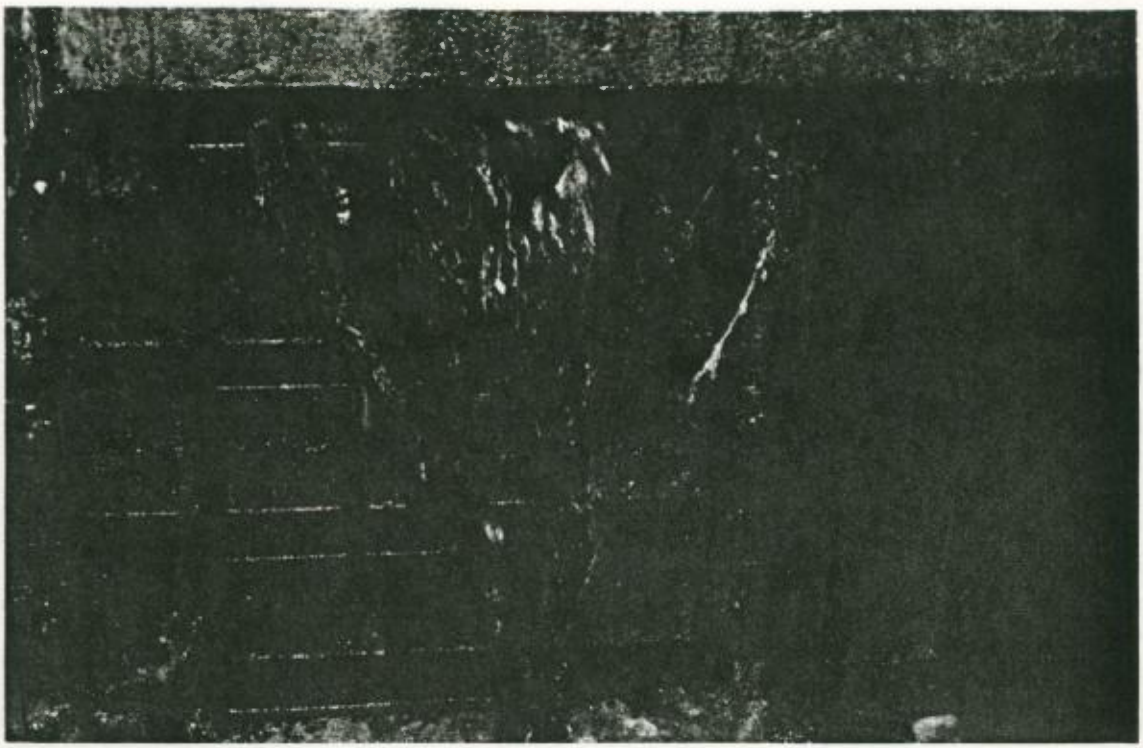
FIG. 53-A, HYDRAULICALLY OPERATED SLUICE GATE AT REGULATOR B-1, JOHNSON AVENUE EAST OF MORGAN AVENUE, BROOKLYN, NEW YORK

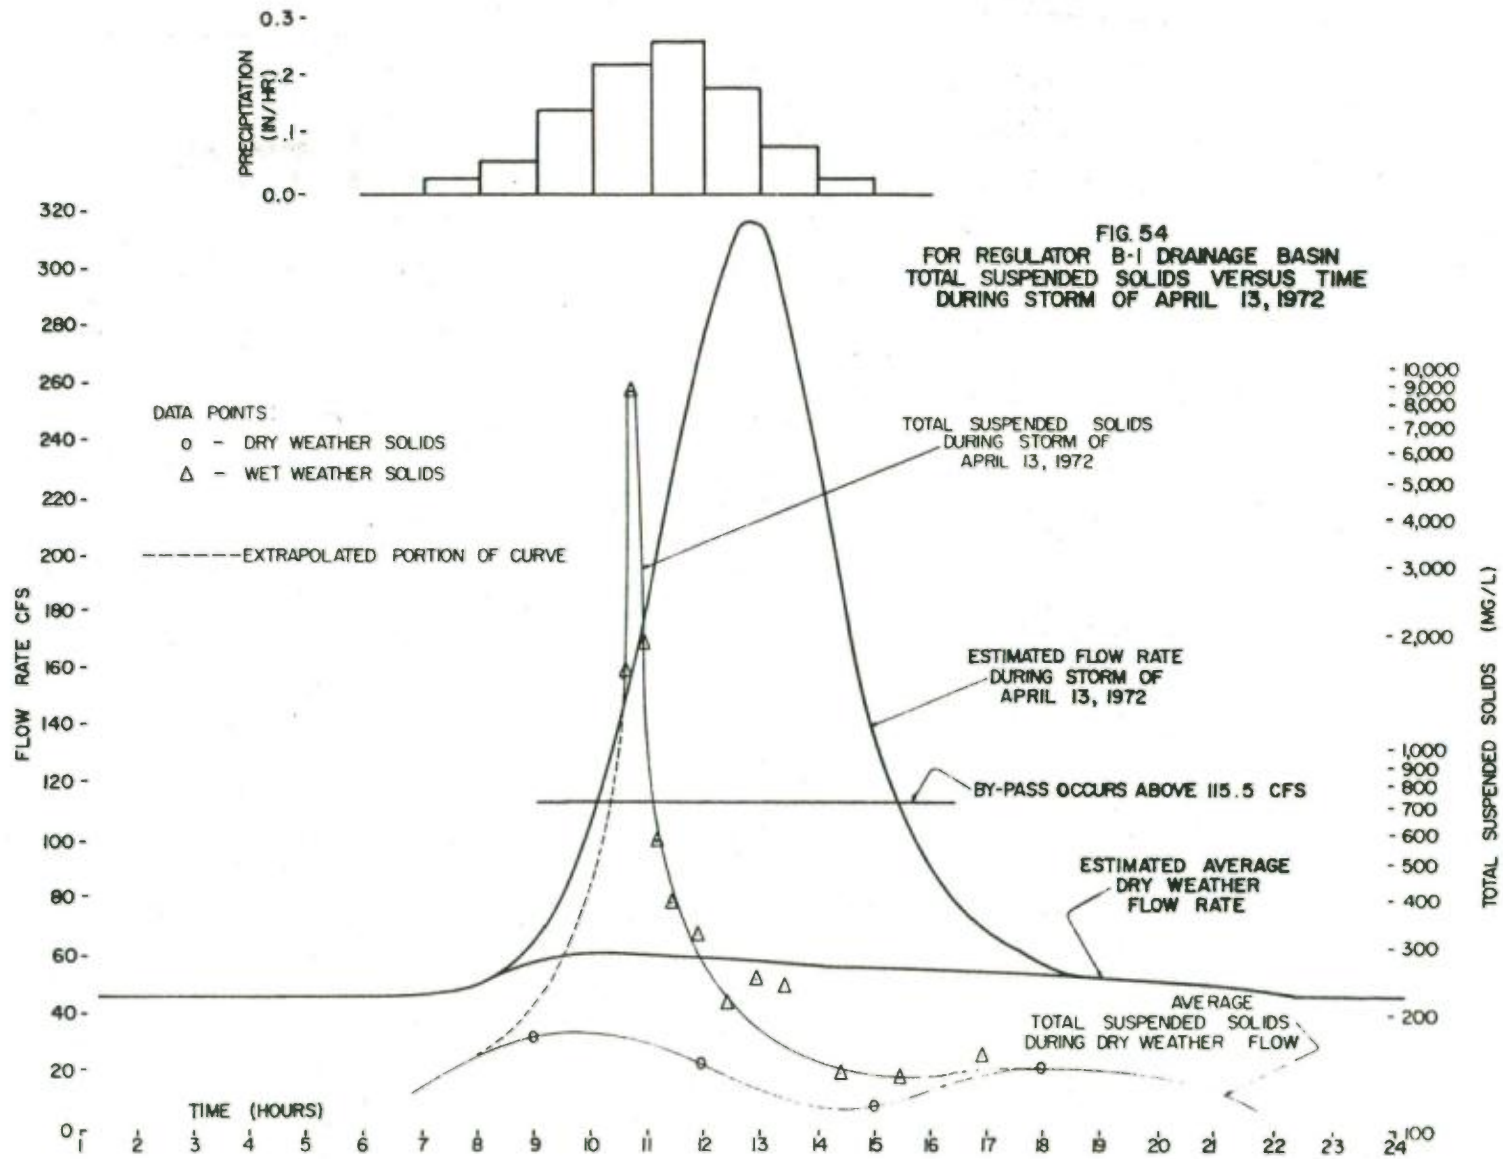
PRECIPITATION (IN/HR)
0.3
.2
.1
0.0
FIG. 54
FOR REGULATOR B-1 DRAINAGE BASIN
TOTAL SUSPENDED SOLIDS VERSUS TIME
DURING STORM OF APRIL 13, 1972
DATA POINTS
o - DRY WEATHER SOLIDS
Δ - WET WEATHER SOLIDS
------EXTRAPOLATED PORTION OF CURVE
TOTAL SUSPENDED SOLIDS DURING STORM OF APRIL 13, 1972
ESTIMATED FLOW RATE DURING STORM OF APRIL 13, 1972
BY-PASS OCCURS ABOVE 115.5 CFS
ESTIMATED AVERAGE DRY WEATHER FLOW RATE
AVERAGE TOTAL SUSPENDED SOLIDS DURING DRY WEATHER FLOW
FLOW RATE CFS
320
300
280
260
240
220
200
180
160
140
120
100
80
60
40
20
0
TOTAL SUSPENDED SOLIDS (MG/L)
10,000
9,000
8,000
7,000
6,000
5,000
4,000
3,000
2,000
1,000
900
800
700
600
500
400
300
200
100
TIME (HOURS)
1 2 3 4 5 6 7 8 9 10 11 12 13 14 15 16 17 18 19 20 21 22 23 24

The two storms that were sampled were of distinctly different characteristics. During the storm which occurred on April 13, 1972, 0.97 inches of rain fell over a 9-hour period with a peak intensity between 11 A.M. and 12 noon EST of 0.26 inches per hour. As can be seen on Figure 54, the hydrograph of the rainfall approximates a normal distribution and may be considered to be typical of a spring day-long rain storm. The storm previous to this occurred on April 4, more than a week prior, during which 0.31 inches of rain fell.

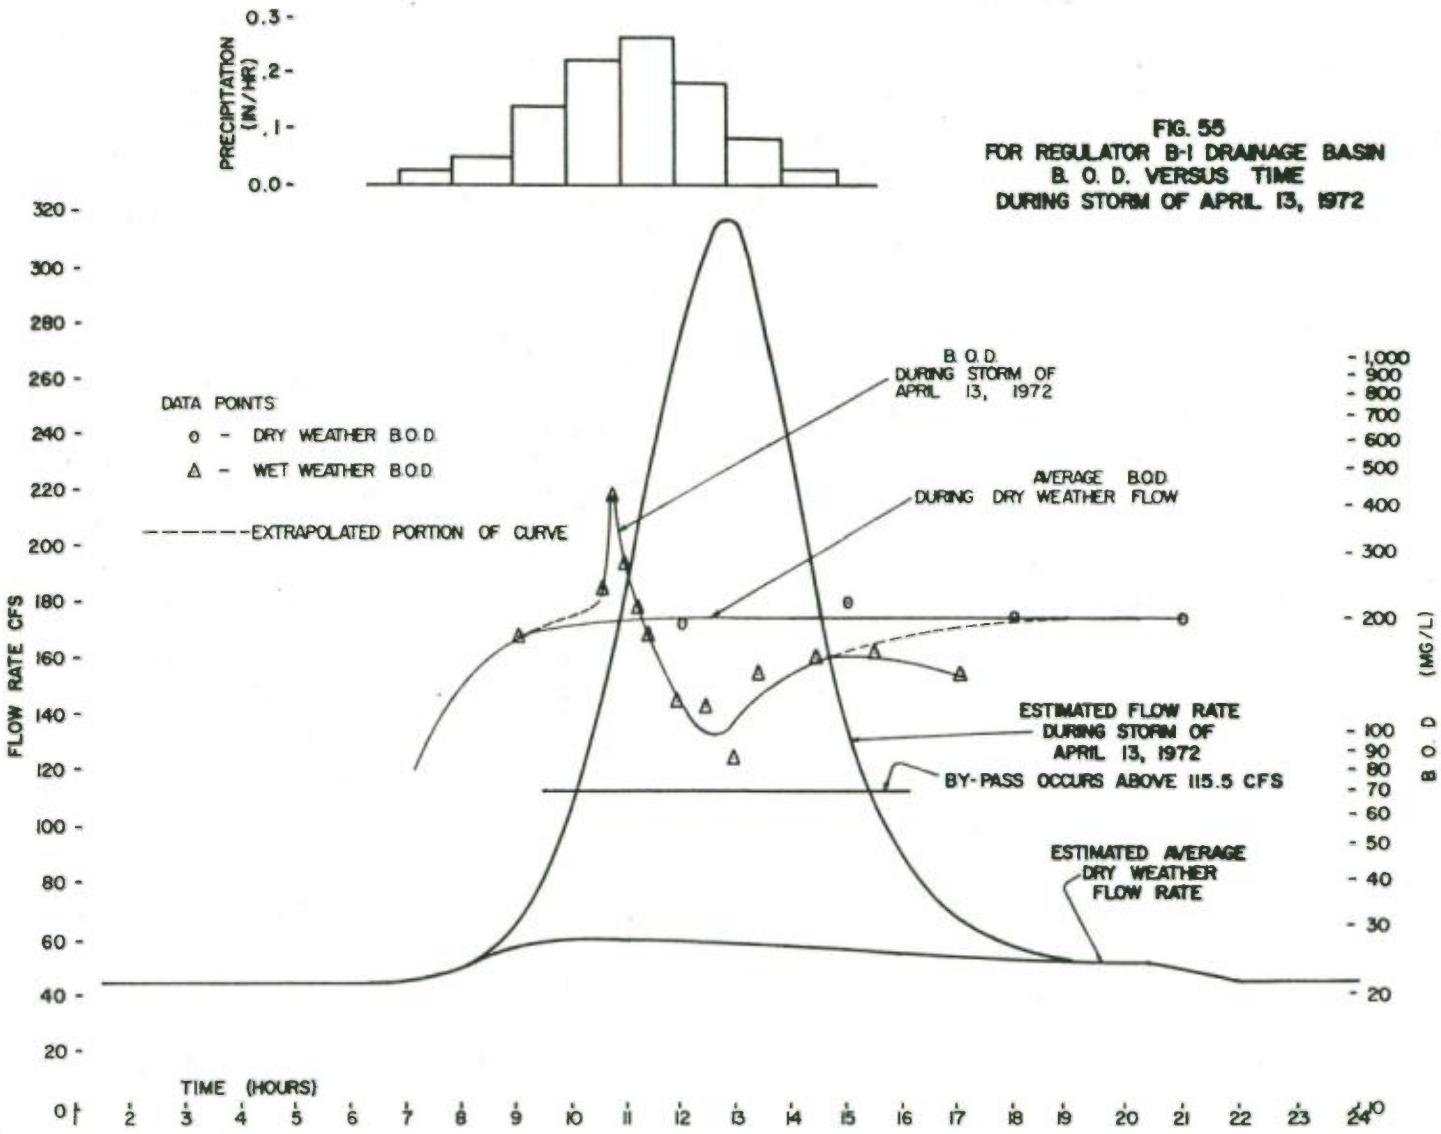
PRECIPITATION (IN/HR)
0.3
.2
.1
0.0
FIG. 55
FOR REGULATOR B-1 DRAINAGE BASIN
B. O. D. VERSUS TIME
DURING STORM OF APRIL 13, 1972
B. O. D. DURING STORM OF APRIL 13, 1972
AVERAGE B.O.D. DURING DRY WEATHER FLOW
DATA POINTS
o - DRY WEATHER B.O.D.
Δ - WET WEATHER B.O.D.
------EXTRAPOLATED PORTION OF CURVE
ESTIMATED FLOW RATE DURING STORM OF APRIL 13, 1972
BY-PASS OCCURS ABOVE 115.5 CFS
ESTIMATED AVERAGE DRY WEATHER FLOW RATE
FLOW RATE CFS
320
300
280
260
240
220
200
180
160
140
120
100
80
60
40
20
B. O. D. (MG/L)
1,000
900
800
700
600
500
400
300
200
100
90
80
70
60
50
40
30
20
TIME (HOURS)
0
1
2
3
4
5
6
7
8
9
10
11
12
13
14
15
16
17
18
19
20
21
22
23
24

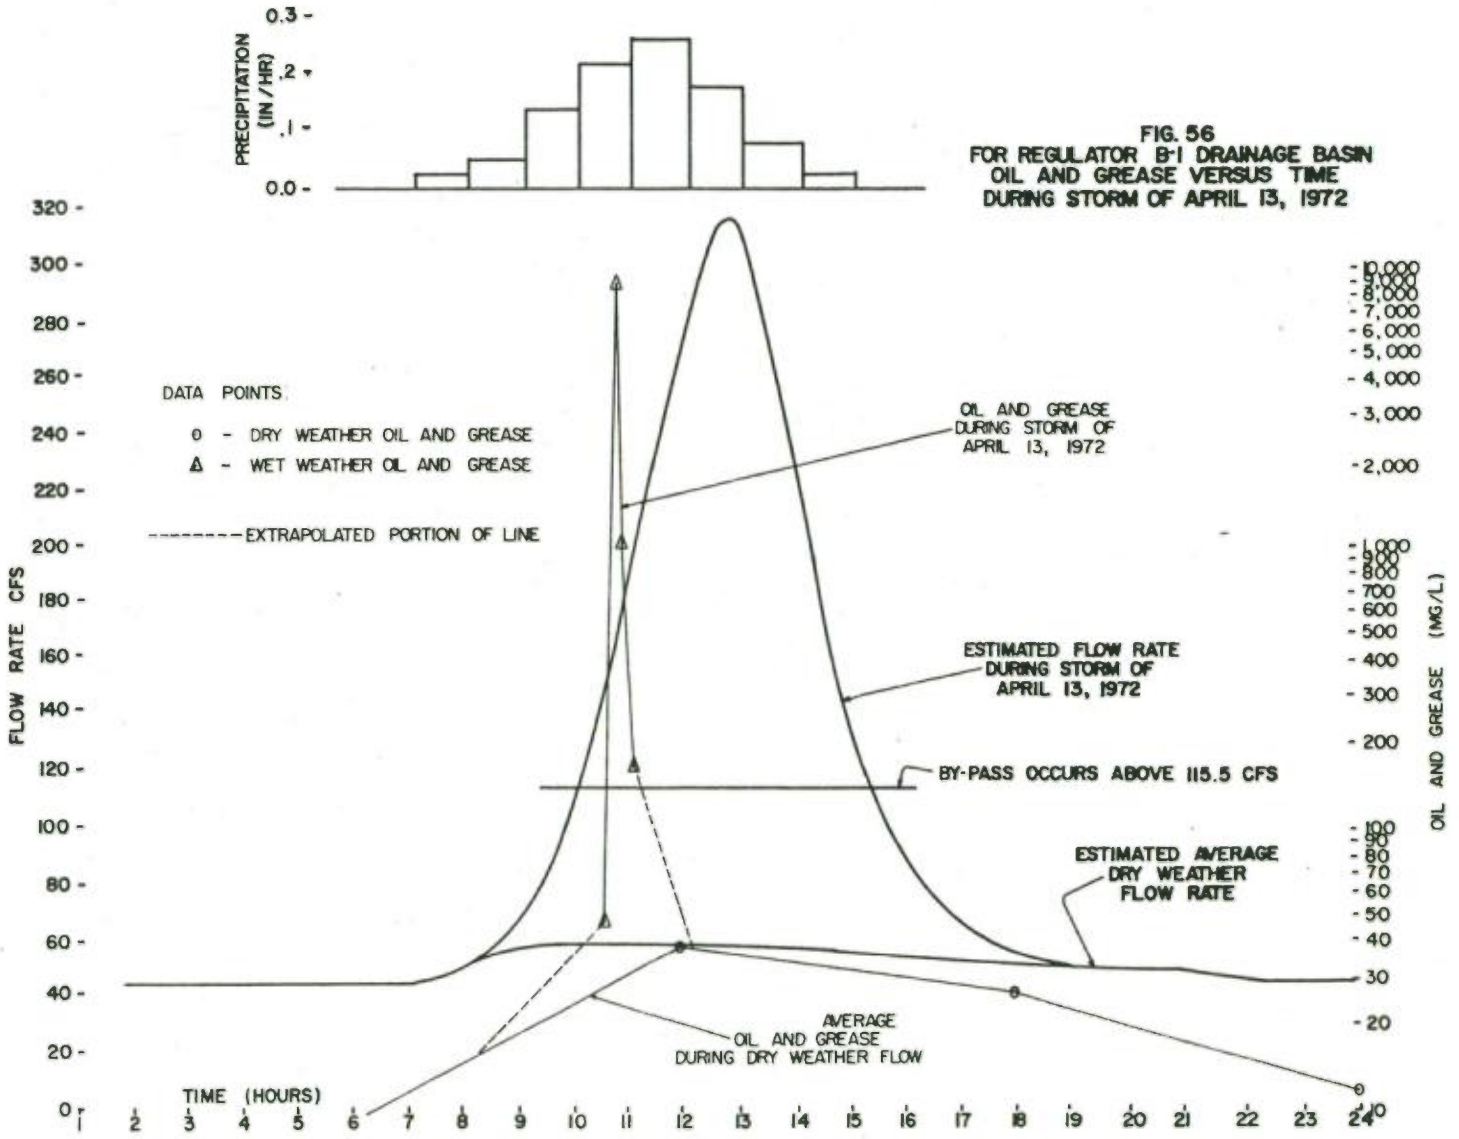
PRECIPITATION (IN./HR.)
0.3
.2
.1
0.0
FIG. 56
FOR REGULATOR B-1 DRAINAGE BASIN
OIL AND GREASE VERSUS TIME
DURING STORM OF APRIL 13, 1972
FLOW RATE CFS
OIL AND GREASE (MG/L)
DATA POINTS
o - DRY WEATHER OIL AND GREASE
Δ - WET WEATHER OIL AND GREASE
--------EXTRAPOLATED PORTION OF LINE
OIL AND GREASE DURING STORM OF APRIL 13, 1972
ESTIMATED FLOW RATE DURING STORM OF APRIL 13, 1972
BY-PASS OCCURS ABOVE 115.5 CFS
ESTIMATED AVERAGE DRY WEATHER FLOW RATE
AVERAGE OIL AND GREASE DURING DRY WEATHER FLOW
TIME (HOURS)

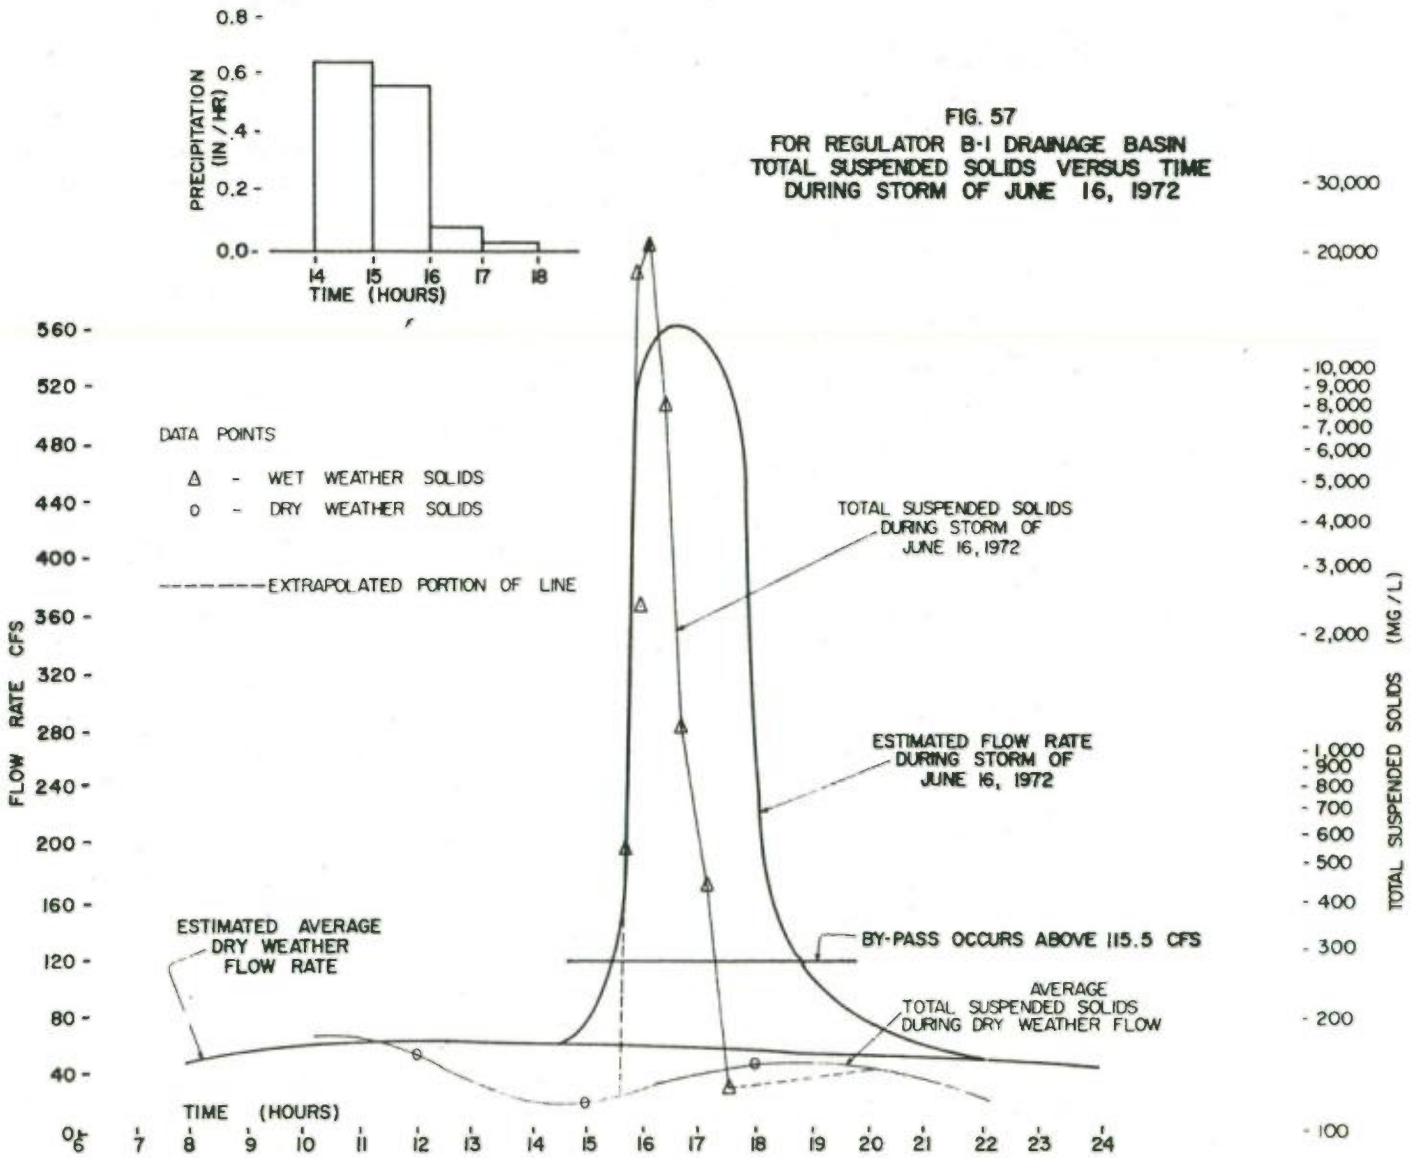
FIG. 57
FOR REGULATOR B-1 DRAINAGE BASIN
TOTAL SUSPENDED SOLIDS VERSUS TIME
DURING STORM OF JUNE 16, 1972

The storm which occurred on June 16, 1972, was of a completely different nature. During this storm, a total of 1.31 inches of rain fell and as can be seen from the hydrograph on Figure 57, the total rainfall occurred over a 4-hour period. During the initial two hours, 1.22 inches fell with the peak intensity of 0.65 inches per hour occurring between 2 and 3 P.M. EST. This type of storm is perhaps typical of a summer thunderstorm due to its high intensity and short duration. In fact, this storm has established a new record for rainfall on this date. The rainfall previous to the June 16 date occurred on June 10, during which 0.19 inches of rain fell. Trace amounts of rain also fell on June 12, 13, 14, and 15, which totaled approximately 0.01 to 0.02 inches.
